RICHLAND COUNTY GEODETIC SURVEY MARKER

POINT NUMBER: 8028A

RICHLAND COUNTY CONTROL POINTS

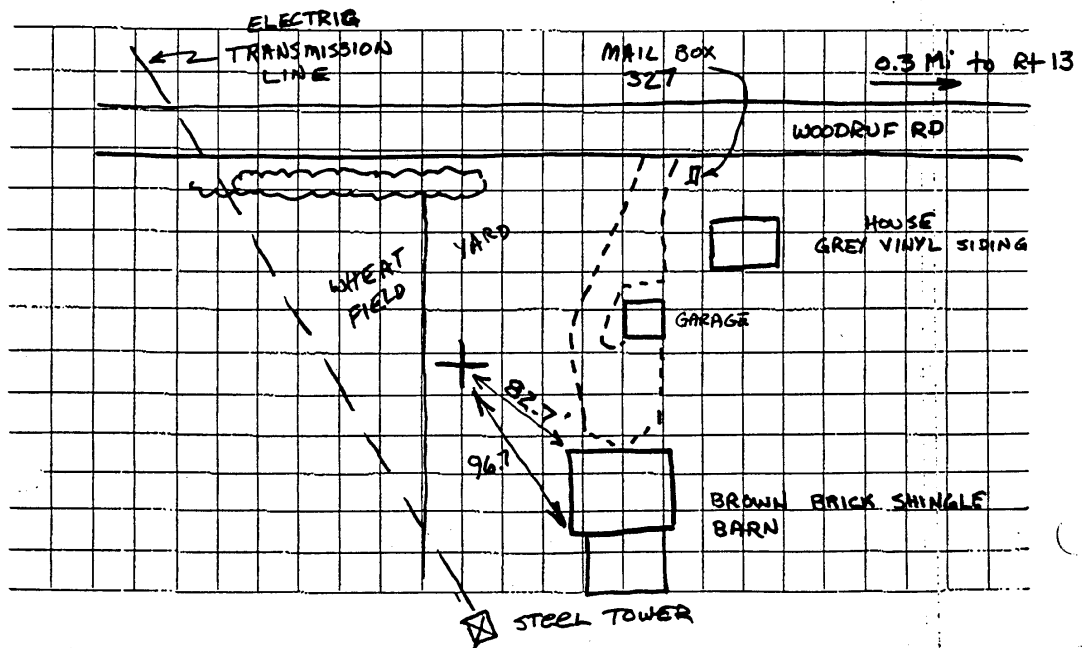
STATION SKETCH

LOCATION: The station is located in Richland County, Ohio about 3 mile(s) North of the Village of Bellville. To reach the station from the intersection of S.R. 97 and S.R. 13 proceed North along S.R. 13, 3.1 mile(s) to its intersection with Woodruff Rd. Turn left and proceed west along Woodruff Rd, 0.4 mile(s). The station is on the left.
