# RICHLAND COUNTY GEODETIC SURVEY MARKER

## OHIO NORTH ZONE (3401)

<b>POINT NUMBER:</b> 8805A

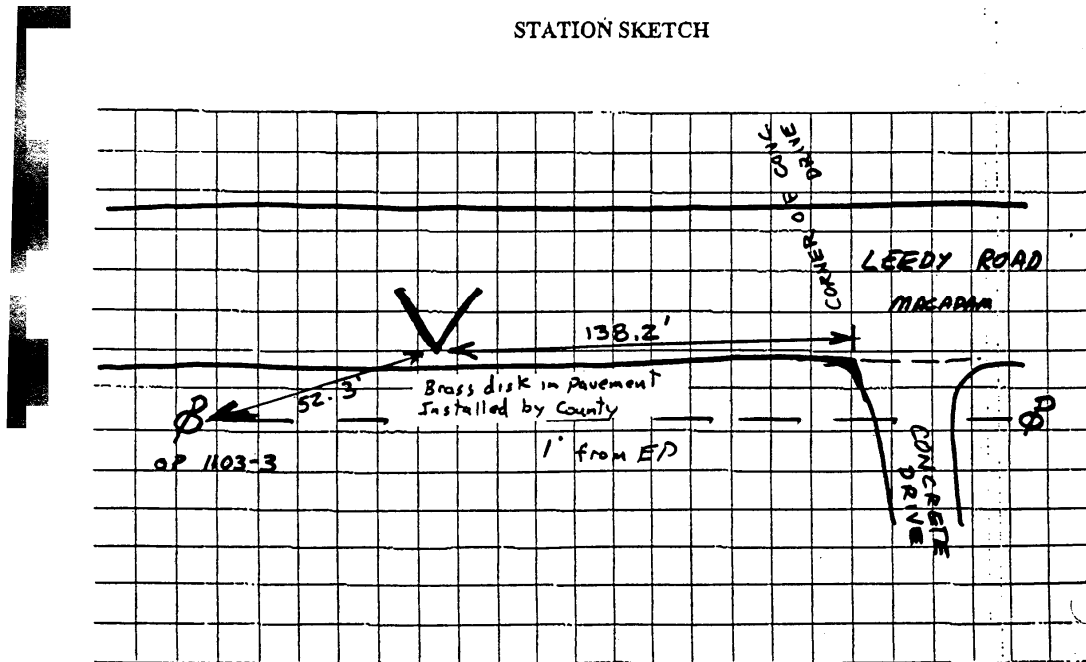
STATION SKETCH

<p style="font-size: small; margin: 0;">Produced by Richland County, Ohio Engineers Office Thomas E. Beck P.E., P.S.</p> <p style="font-size: x-small; margin: 0;">77 North Mulberry Street Mansfield, Ohio 44802 Ph 419-774-5591 Fax 419-774-5539 3/03</p>
<b>R/T/S:</b> 18-18-05    Knox Co. Line	
<b>STATION NAME:</b> 10	
<b>TYPE OF MARK:</b> Brass Disk in Pavement	
<b>SET BY:</b> County	
<b>STAMPING ON MARK:</b> GPS STATION RICHLAND COUNTY	
<b>DATE SET:</b> 1995.	
<b>METHOD OF SURVEY:</b> GPS	
<b>FILE:</b> 1995 Report, 2003 Report	
<b>COORDINATES BY:</b> Geometrics	
<p><b>LOCATION:</b> The station is located in Richland County, Ohio about 5 miles South of the Village of Bellville. To reach the station from the intersection SR 13 and SR 97 proceed South along S.R. 13, 5.4 miles to its intersection with Leedy Rd. Turn right and proceed west along Leedy Rd, 0.2 mile(s). The station is on the left.</p>
