RICHLAND COUNTY GEODETIC SURVEY MARKER

POINT NUMBER: 8909A

STATION NAME: 28

RICHLAND COUNTY CONTROL POINTS

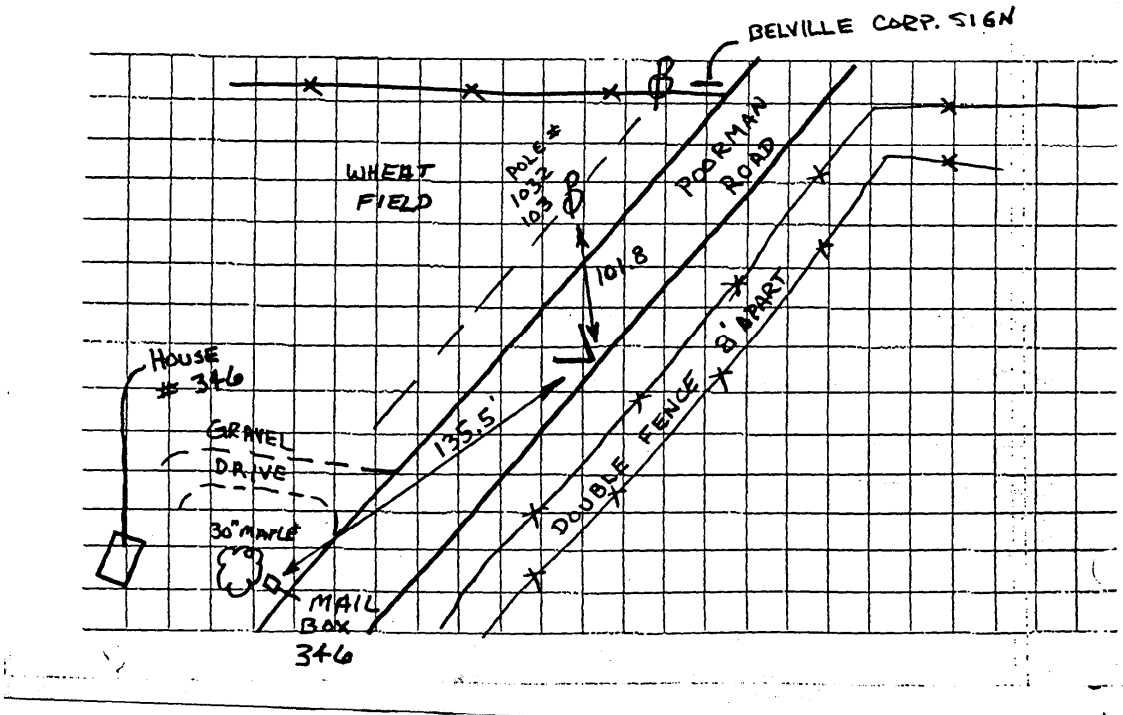
STATION SKETCH

LOCATION: The station is located in Richland County, Ohio about 1 mile(s) SW of the Village of Bellville. To reach the station from the intersection of S.R. 13 and Durbin Ave proceed West along Durbin Ave, 0.5 mile(s) to its intersection with Poorman Rd. Turn left and proceed Southwest along Poorman Rd, 0.3 mile(s) The station is on the left.
